1. Scope of the Investigation. Under the terms of reference contained in the letter of the Minister of Mines, addressed to the Chairman of the Committee on the Paymaster Mines Accident on February 22, 1945, the Committee considered that its duty was to investigate matters of safety with respect to hoisting only. It has consequently not undertaken to inquire into the safety of mining operations generally. For example, it has not concerned itself with accidents having to do with explosives, fall of rock, rock bursts, stoping, horizontal transport, electrical or fire hazards, surface, mill or metallurgical operations.

B—CAUSES OF THE PAYMASTER ACCIDENT

5. Rope Corrosion the Primary Cause. Following a careful study of all the available evidence, this Committee is definitely satisfied that the fall of the mine cage in No. 5 shaft of the Paymaster Consolidated Mines, Limited, which occurred on February 2, 1945, with the loss of sixteen lives, was primarily due to corrosion of the hoisting rope. The Committee incidentally concurs in the verdict of the Coroner's Jury that the failure of the rope was "because of internal corrosion, of which there was no indication from external examinatio

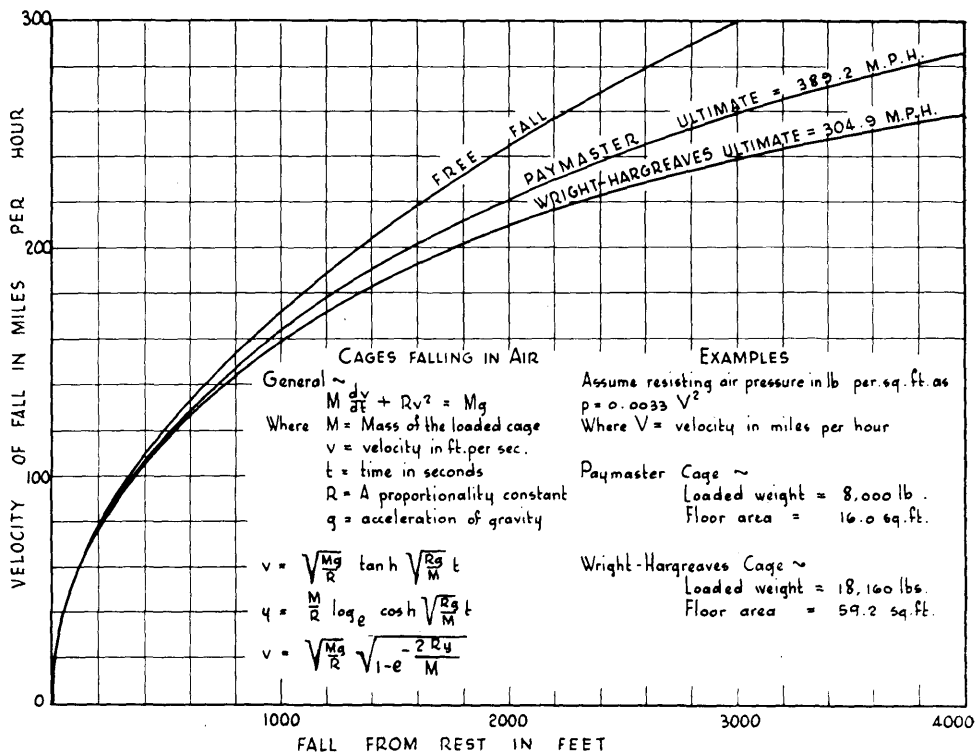
Fig. 4—Velocities of Mine Cages Falling in Air

Fig. 4 indicates the extent to which the velocities of cages falling in air build up with distance fallen. While in a mine shaft the velocities attained would not be quite so large as are shown in the figure, the comparatively free escape of air under a cage into the adjoining compartments would prevent any very great cushioning effect.

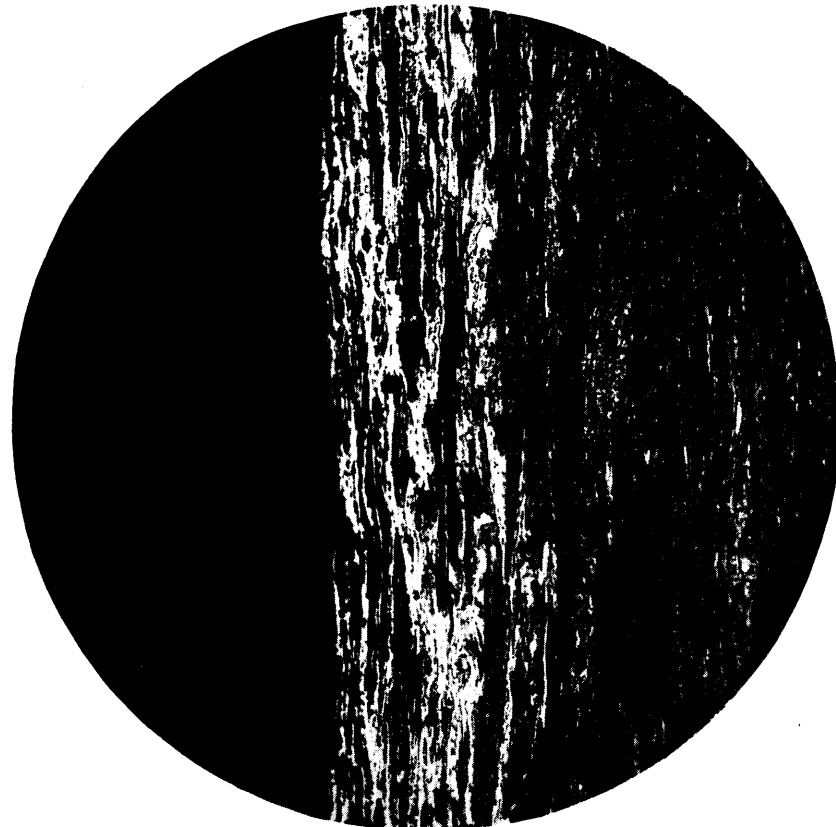
Fig. 10—Longitudinal view of edge of wire. Showing surface decarburization to depth of .004 inches
Magnification $\times 250$

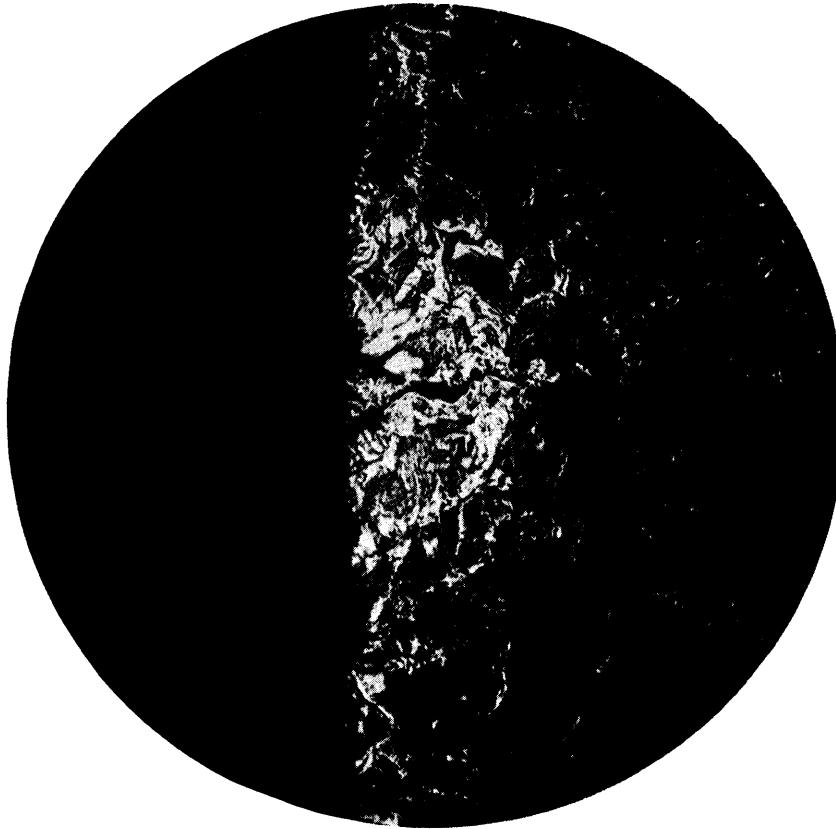
Fig. 11—Cross Section view of edge of used wire. Showing fatigue crack in decarburized zone
Magnification $\times 500$

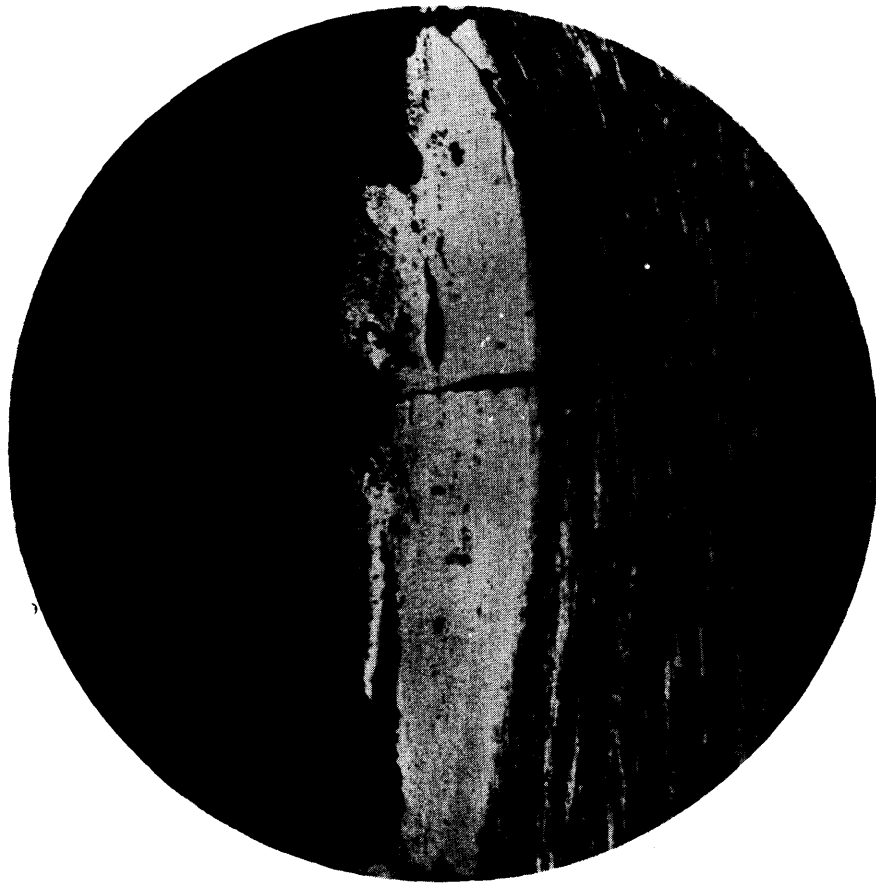
Fig. 17—Martensite on Hoisting Rope. It is some-
times white etching and structureless.
Magnification $\times 500$

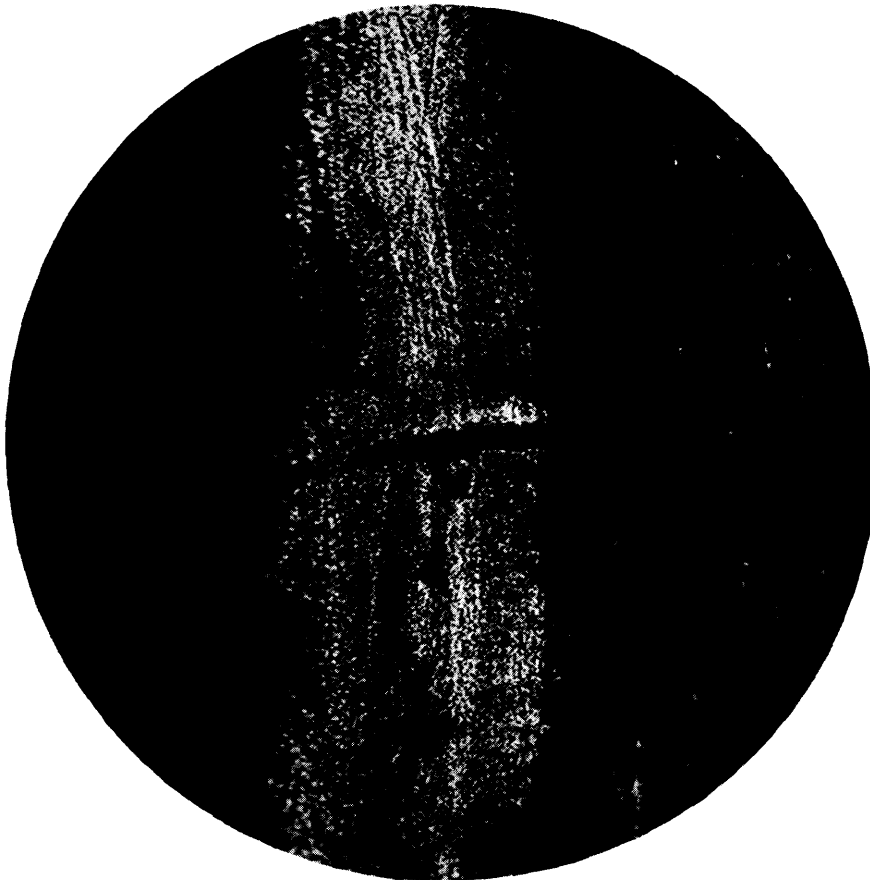
Fig. 18—Same Field after Tempering. Shows familiar dark etching martensite
Magnification $\times 1000$

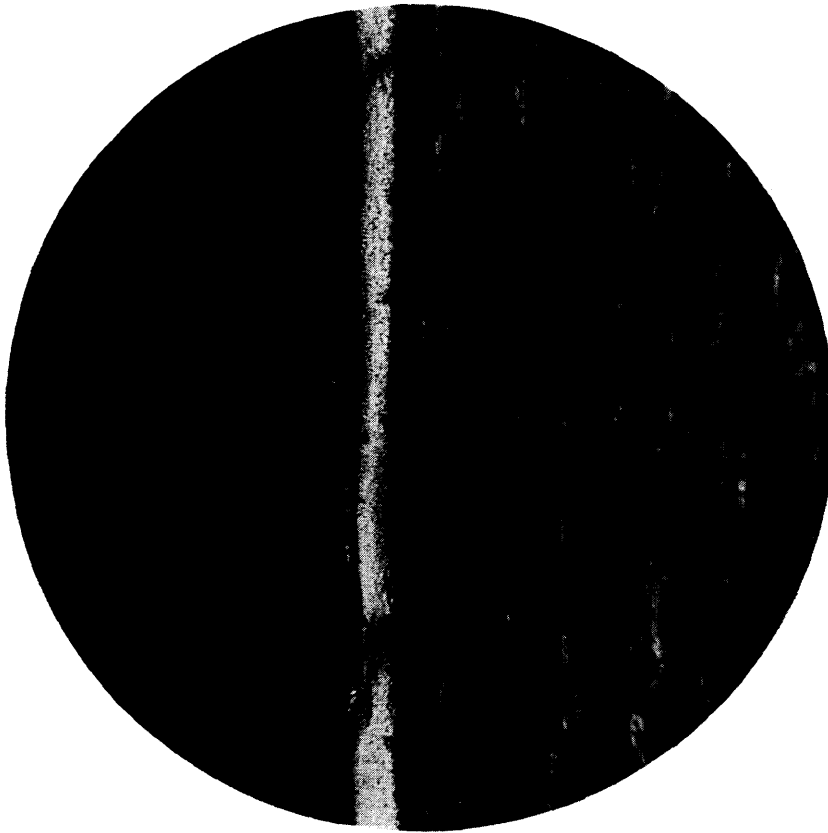
Fig. 19—Martensite on Skip Rope from an Inclined Shaft. Service 13 months
Magnification $\times 500$

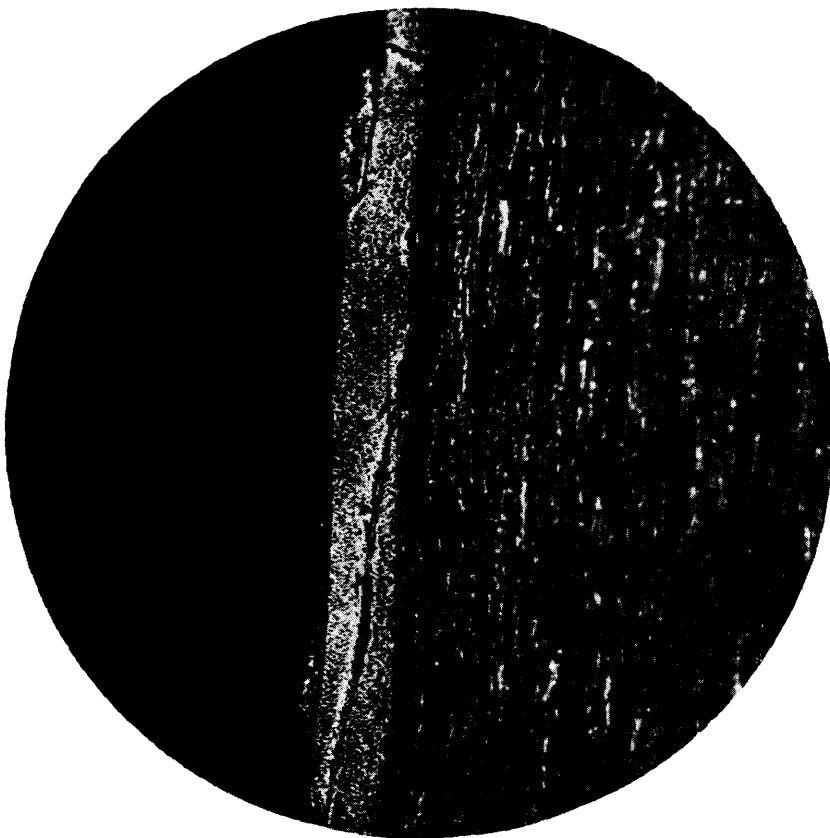
Fig. 20—Martensite on a Cage Rope from a Vertical Shaft. Service 21 months
Magnification $\times 500$

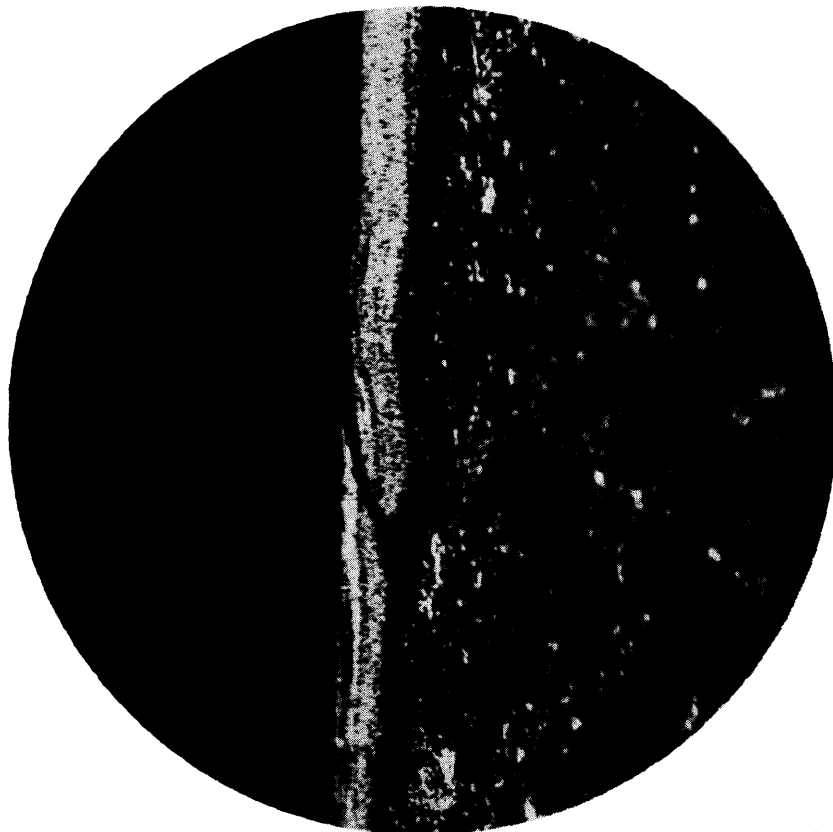
Fig. 21—Martensite on a Cage Rope from a Vertical Shaft. Service 1 month
Magnification $\times 1000$

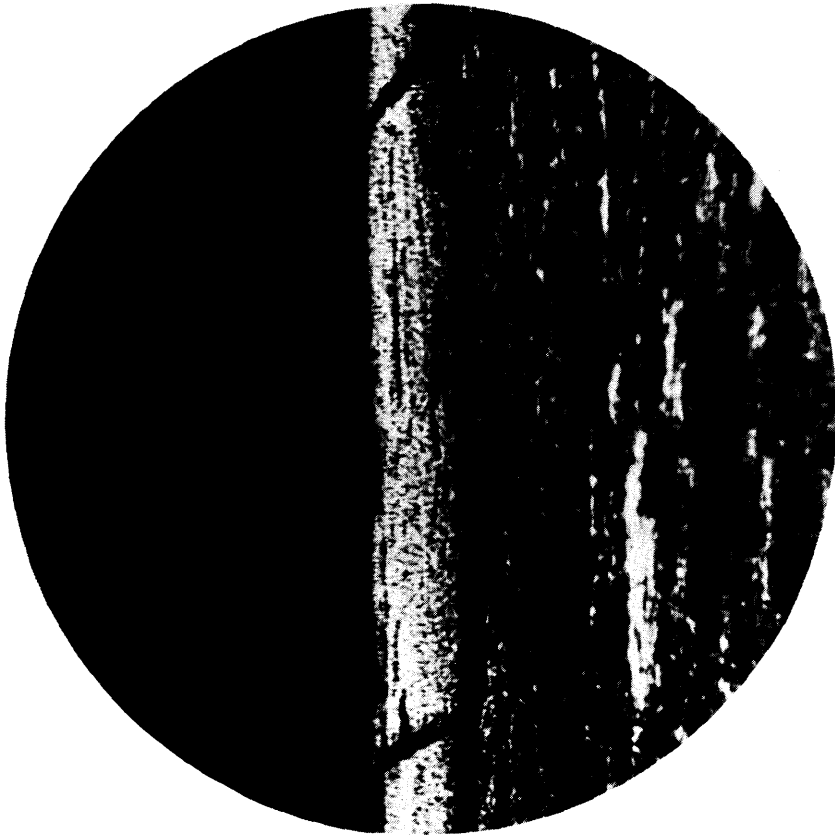
Fig. 23—Martensite on a Cage Rope from a Vertical Shaft.
Service 1 month
Magnification $\times 1000$

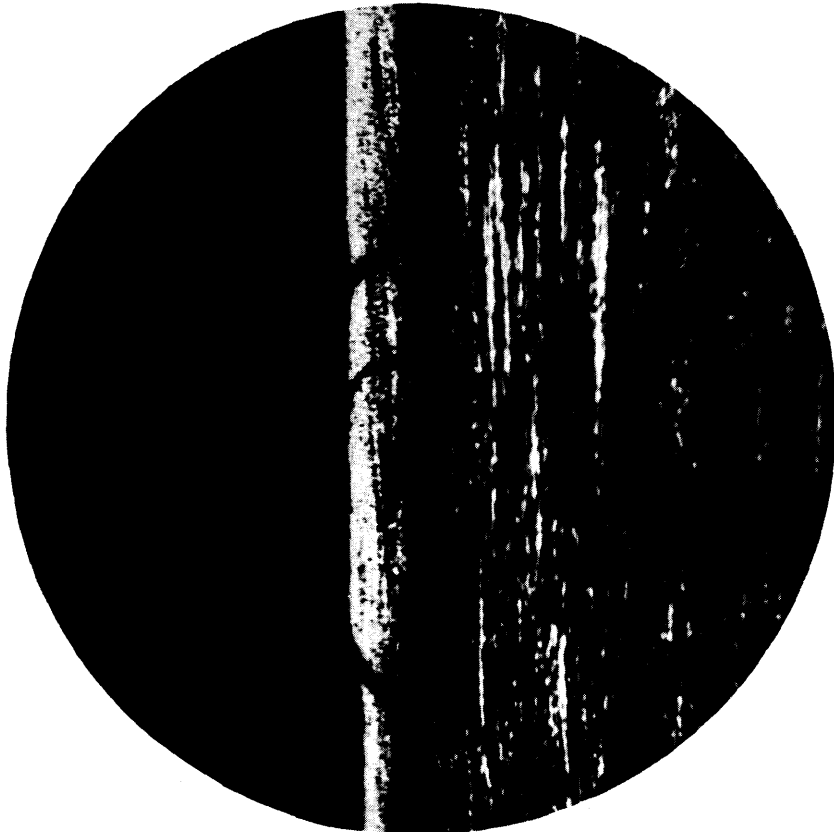
Fig. 22—Martensite on a Cage Rope from a Vertical Shaft.
Service 1 month
Magnification $\times 1000$
