PROVINCE OF ONTARIO
DEPARTMENT OF MINES

EMPLOYMENT AND ACCIDENT STATISTICS (GROUPS 1-6), 1932-56,
SHOWN GRAPHICALLY

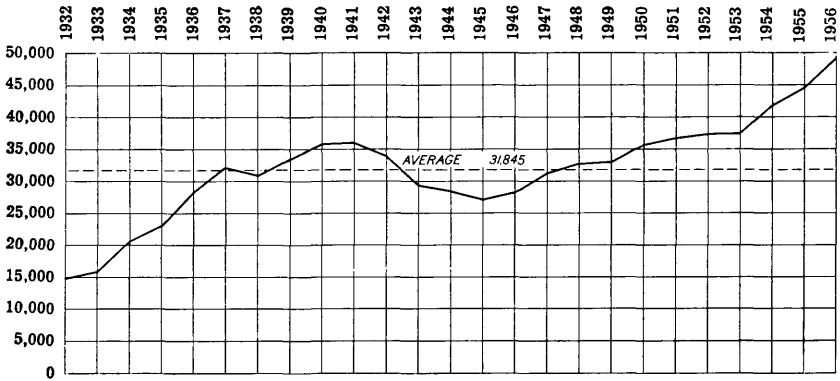
1—NUMBER OF PERSONS EMPLOYED

Total number of persons employed in mining operations (from Table 1).

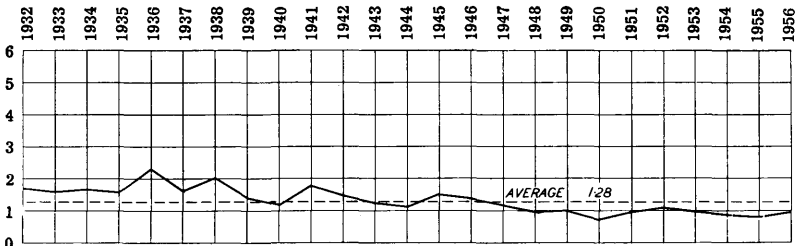
2—FATALITIES PER 300,000 MAN-SHIFTS

Number of fatalities per 300,000 man-shifts in mining operations.

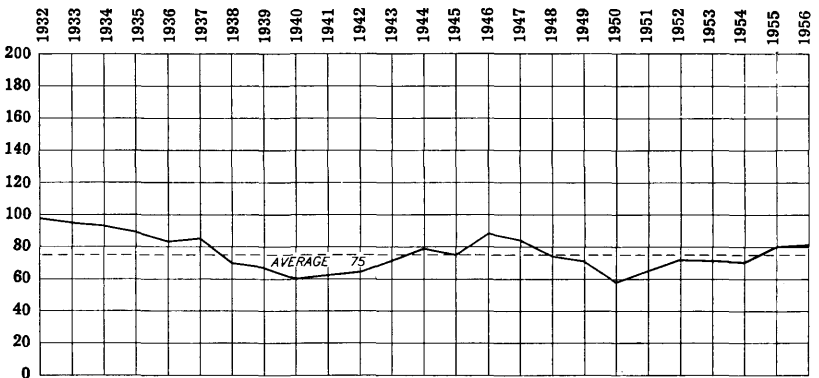
3—NON-FATAL ACCIDENTS PER 300,000 MAN-SHIFTS

Number of non-fatal accidents per 300,000 man-shifts in mining operations.
